Manhole Inspection Summary

Manhole # S23AA1009MH

Insp Date: **1/29/07 1:49 PM**

Location Address: **3603 BUENA VISTA AVE**

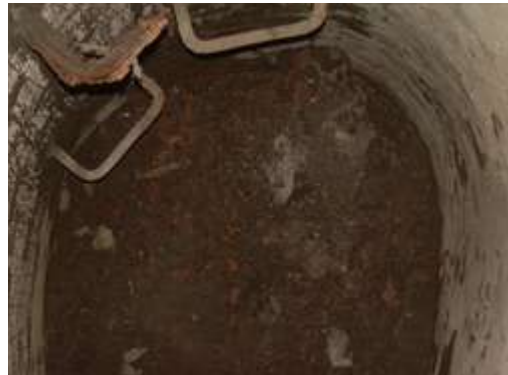
Top View

Barrel infiltration. Corroded and missing steps. Channel debris.

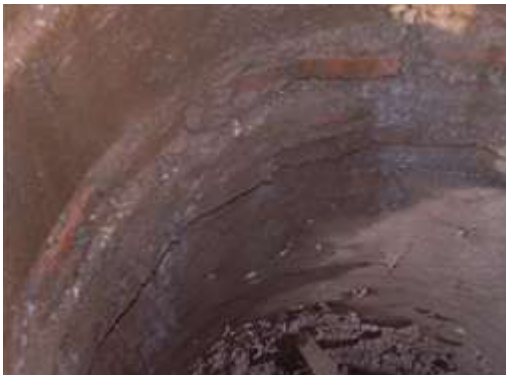
Defect

Frame leaks. Adjustment deterioration and infiltration.

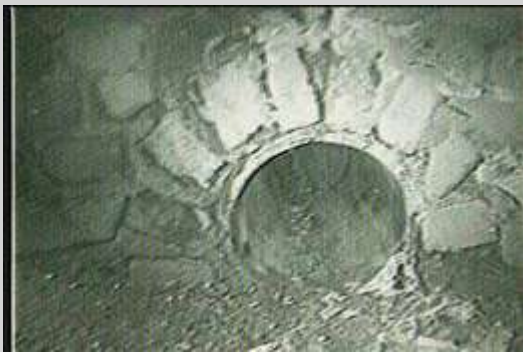
8 in. Circular Gravity Sewer
Pipe Out @ 12 O'Clock

Infiltration: **None** Pipe Seal Cond: **Cracked**
